Abstract

- ## Objectives
- The aim of this study is to detect damaged cultural heritage sites in the earthquake zone of Adiyaman and Hatay in Turkey
 - Assess the magnitude of structural damage to these important piece of history

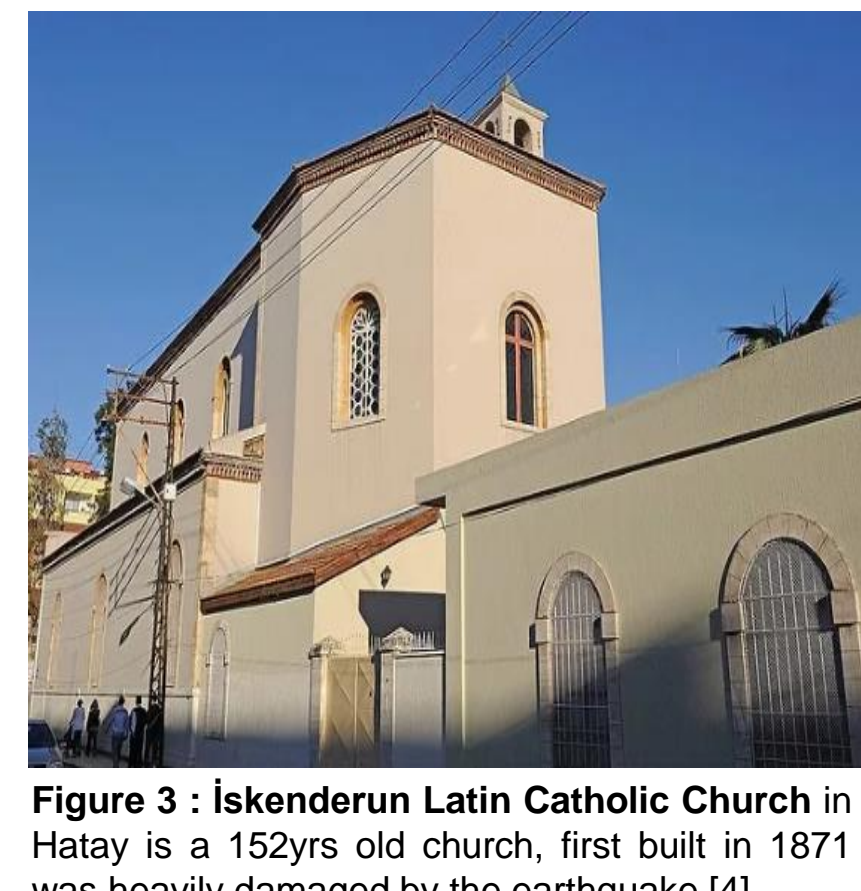
Figure 3: Iskenderun Latin Catholic Church in Hatay is a 152yrs old church, first built in 1871 was heavily damaged by the earthquake.[4]

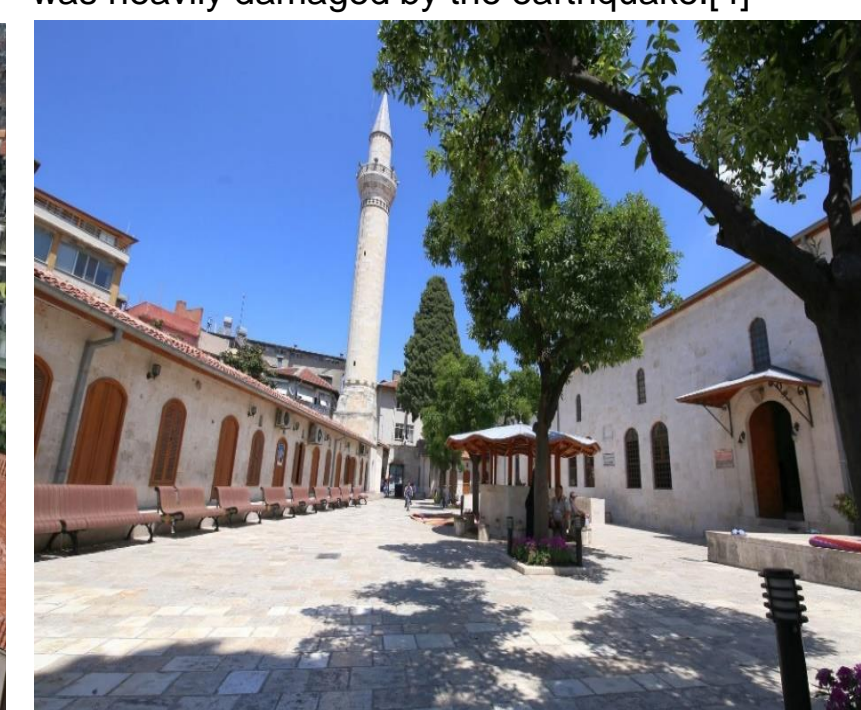
Figure 4: Habib-i Neccar Mosque named after a religious man Habib-i Neccar worked to spread Christianity in Antakya during the Roman era (64 BC–396 AD). The precise date are unknown. There are rumors that the mosque was originally a chapel, which the Syrian Mamluks had destroyed and replaced with a mosque.

Nevertheless, we observed that using different polarization, orbit and incident angle can help to achieve this task. We had different locations and structures to examine and visually interpret which showed us that the level of damages on buildings is also an effective parameter to understand the changes in pixel values in SAR images as was evidently seen in the partially collapsed Habib-i Neccar mosque and totally collapsed Hatay Ulu mosque.

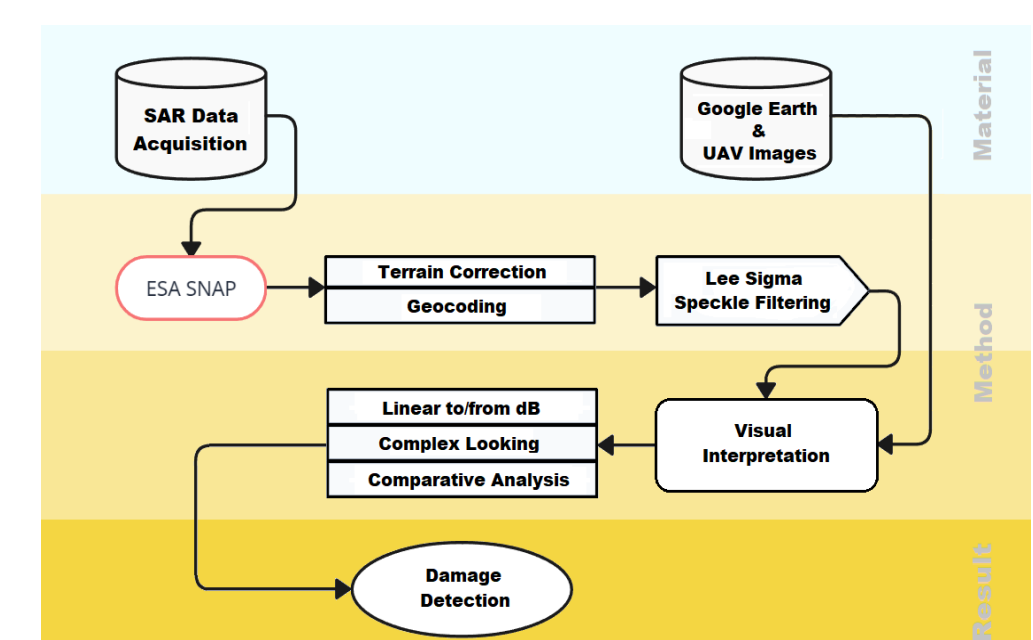
Figure 7: Workflow for TerraSAR-X

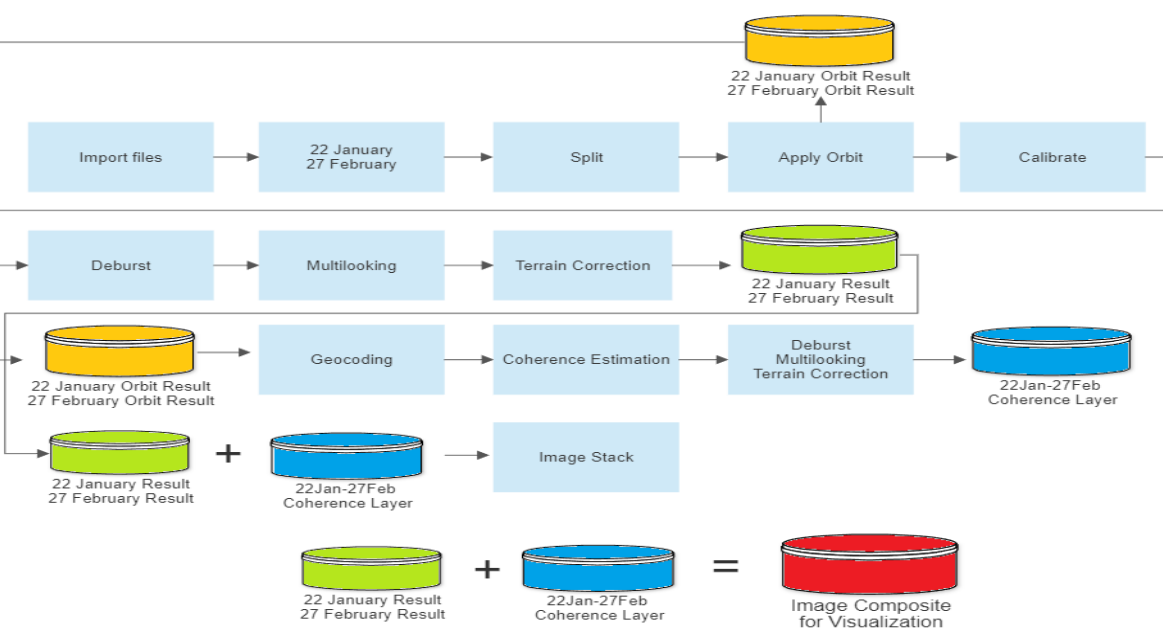
Figure 8: Workflow for Sentinel 1 coherence change detection

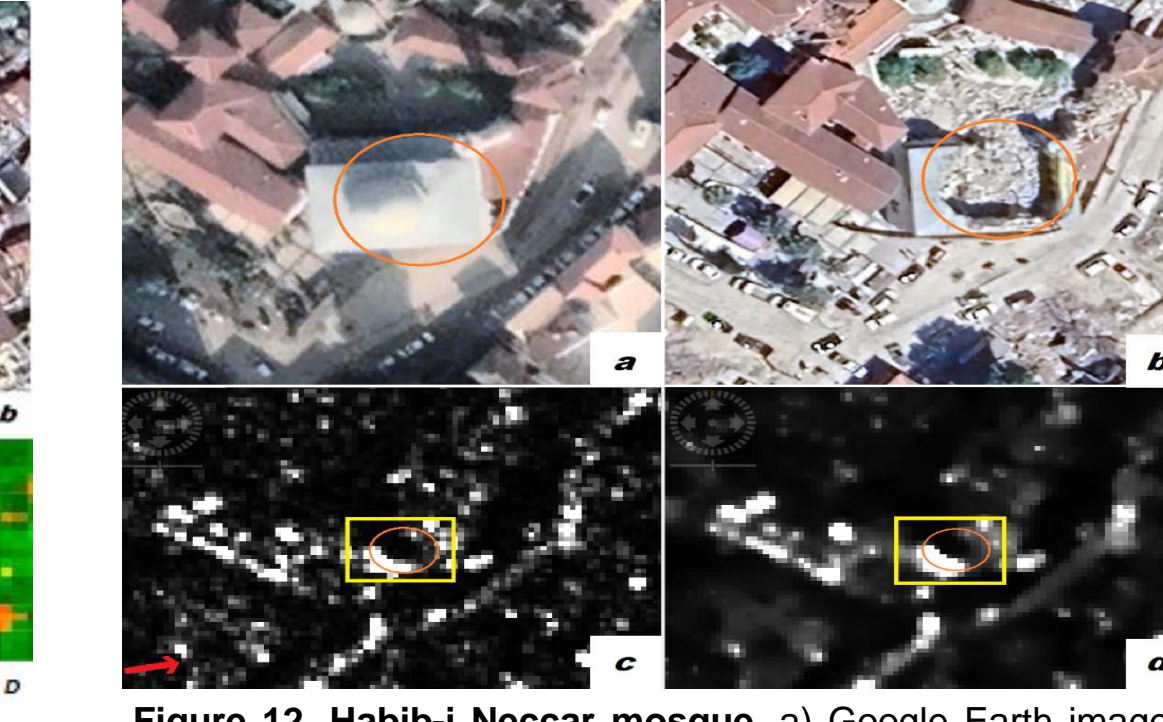
Figure 12: Habib-i Neccar mosque. a) Google Earth image before earthquake, b) Google Earth image after earthquake, c) SAR image, d) Filtered SAR image. Orange circle indicates the area where roof of the mosque is collapsed. (TerraSAR-X Acquisition date : 23 Mar 2023)

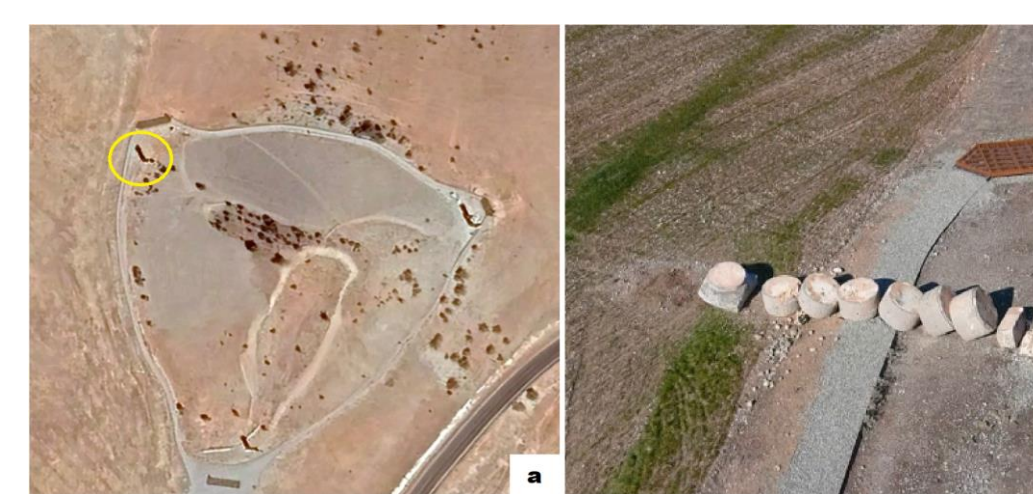
Figure 13: Karakuş Tumulus(a) and collapsed handshake relief (b)

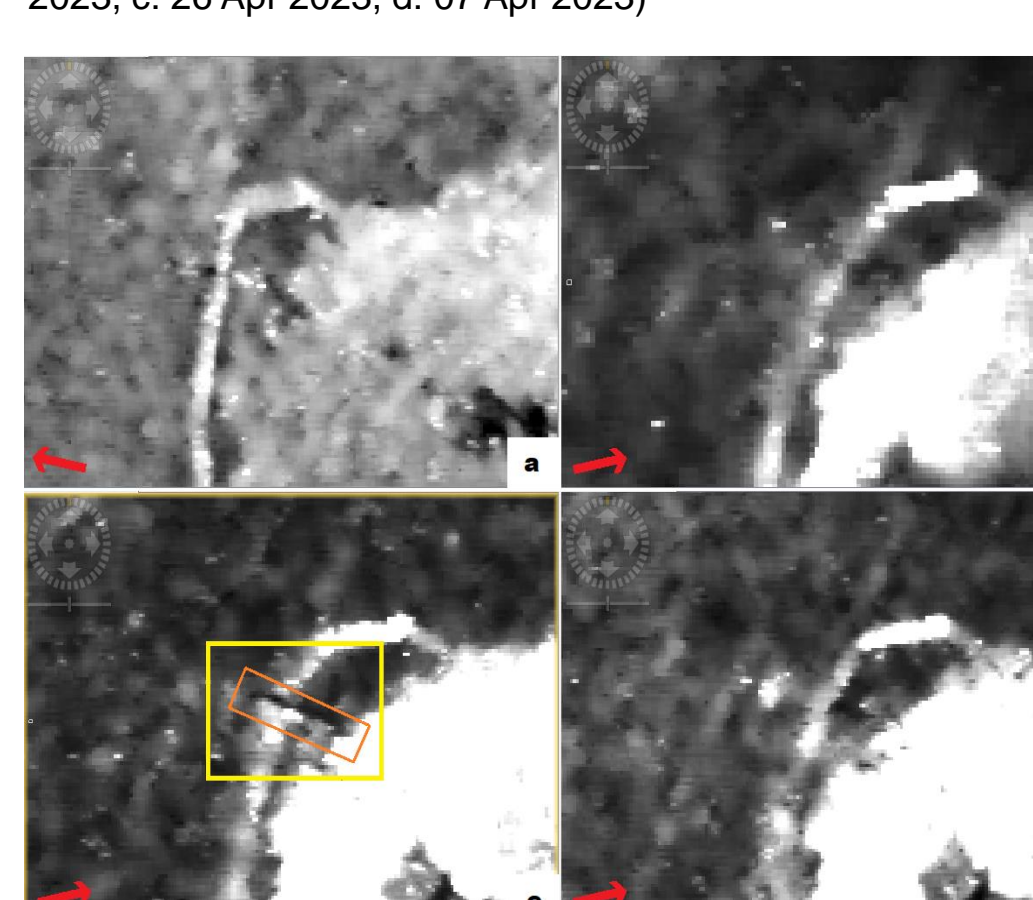
Figure 17: Filtered SAR images of the collapsed column. Orange polygon shows the column on the ground. (SAR Acquisition dates: a: 12 Mar 2023, b: 21 Apr 2023, c: 26 Apr 2023, d: 07 Apr 2023)

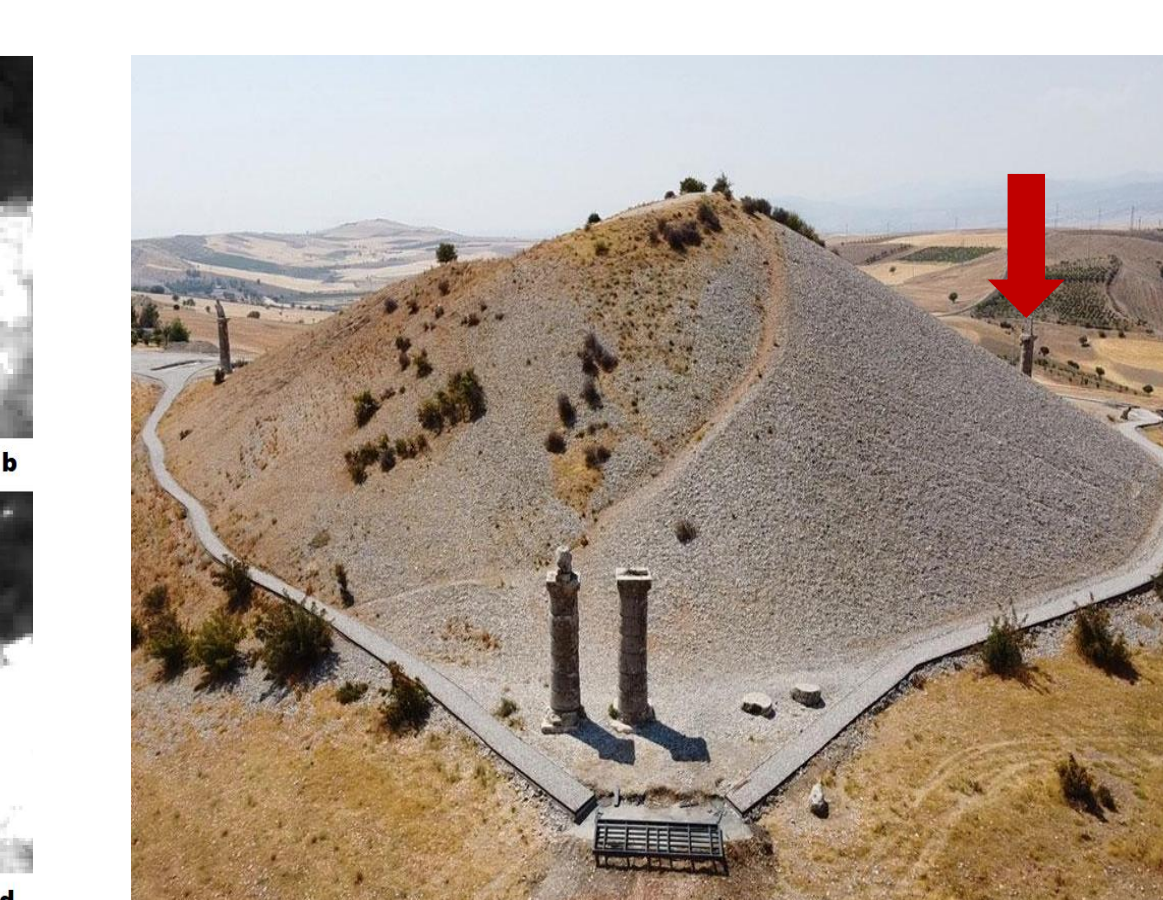
Figure 18: Side view of the Karakuş Tumulus with red arrow pointing to the affected column.

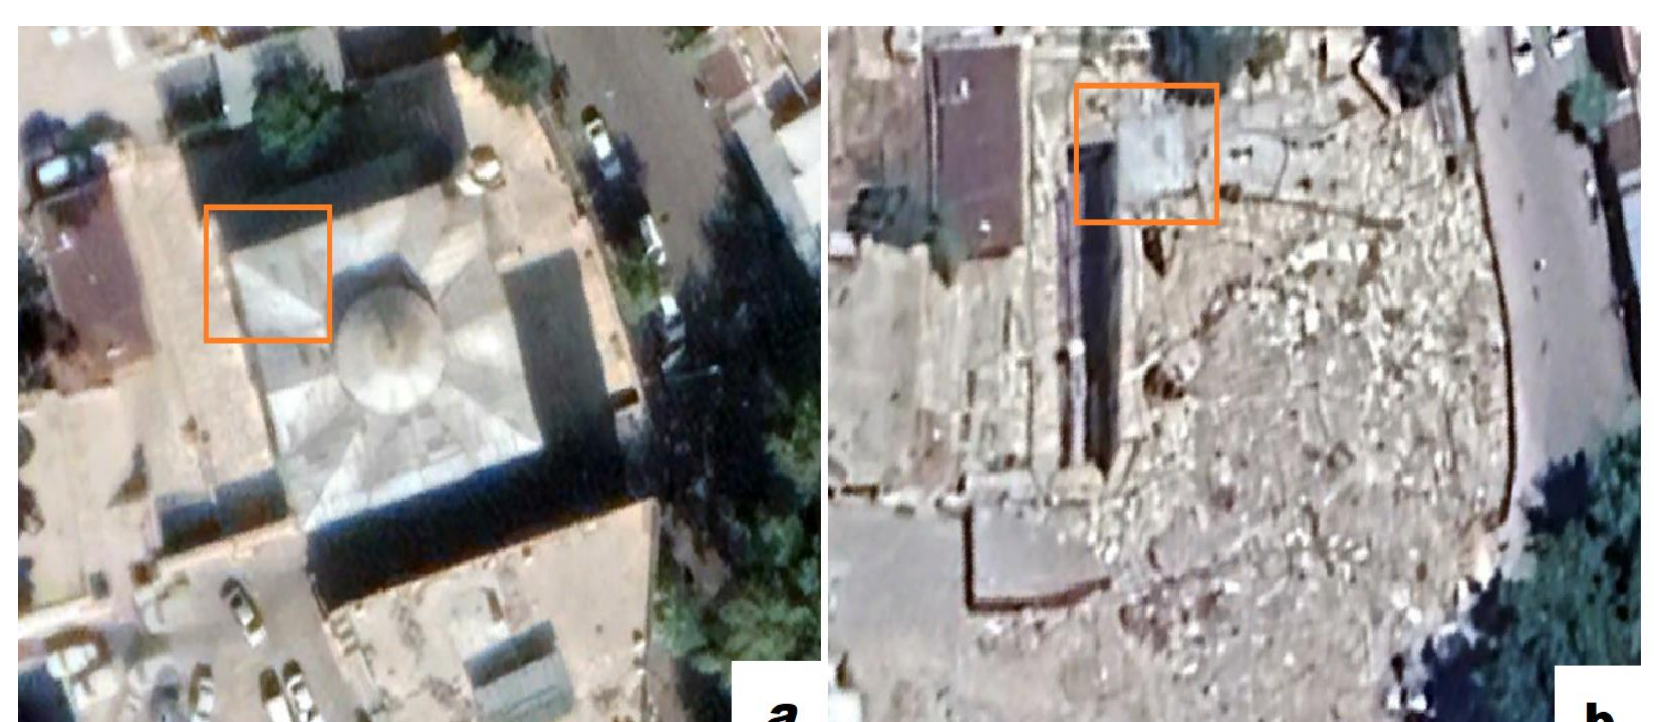
Figure 18: Adiyaman Ulu Mosque. a) Google Earth image before earthquake, b) Google Earth image after earthquake, c) SAR image with the green square indicating the 2m pile of rubble (see e & f), d) Filtered SAR image. Orange square indicate the area where standing part of the roof on north-west, red rectangle marks the brightly scattering makeshift aluminum fence (see f) (SAR Acquisition date: 30 Mar 2023)

In this study, so many factors and parameters were combined to conclusively analyse the result, size of the damage, location of the structure, surrounding structures and coherence change detection played important roles. Because different size of damages backscatter differently and sometimes combining and comparing it with the backscatter from surrounding structures helps delineate the structures and identify damages (see Figure 9 & Figure 10). Also, we could see how the nature of the structural damage made a visible difference between Adiyaman Ulu mosque, Habib-i Neccar mosque and Hatay Ulu mosque where we could detect strong backscatter from the remaining north-west corner of the mosque roof of the Adiyaman Ulu mosque (see figure 12) and the collapsed circular dome of the Habib-i Neccar mosque (see figure 12). Parameters of acquired SAR images play a huge role. Specifically in the case of the Column in Karakuş Tumulus, we have examined how different incident angles and orbits changes the view on the damage. Looking from the right direction is one of the major conditions to see damage in a single SAR image. For instance a thorough examination of the acquisition characteristics for Figures 15, 16, and 17 revealed that three of the four images (b, c, and d) shared the same pass (Ascending) and two of them (c, d) shared the same incidence angle center of 43.16° but had distinct first, last, near, and far longitudes and latitudes
